Education
Funding
Agency

Asbestos in schools: Where it may be located

**Departmental advice for school leaders,
governors, staff, local authorities, academy
trusts and charitable trusts**

February 2017

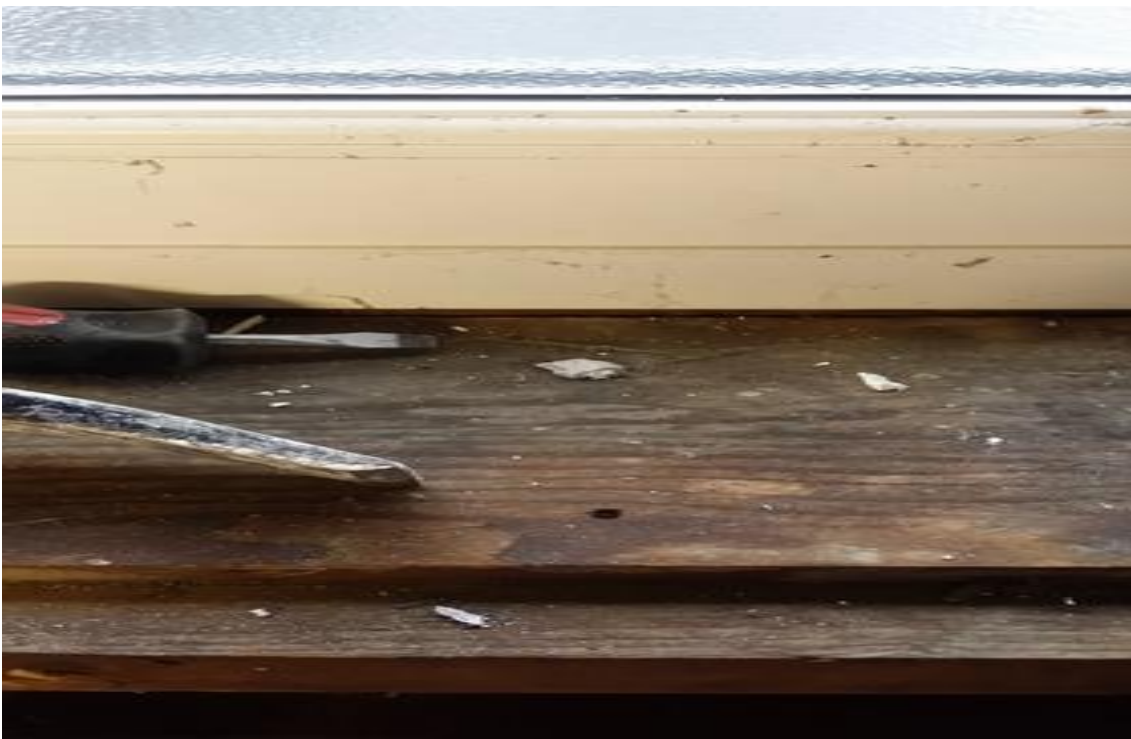
AIB cladding and asbestos debris – asbestos debris from AIB window surround cladding

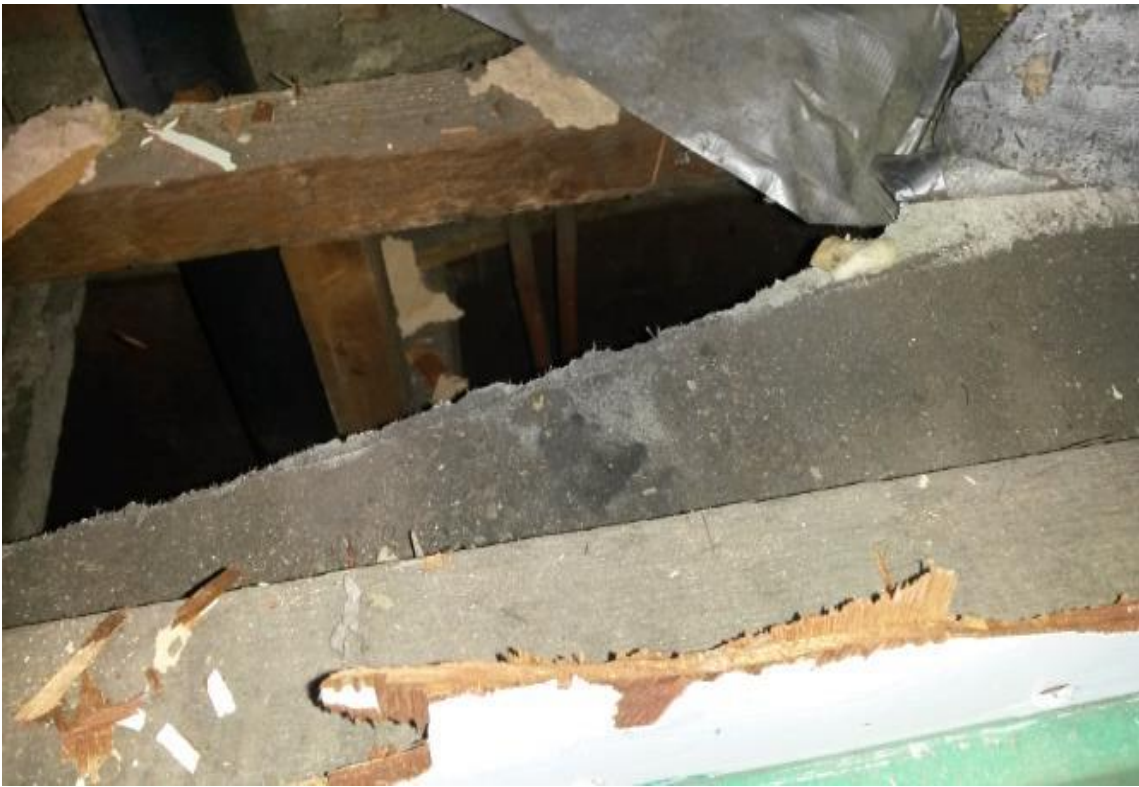
Damaged asbestos panelling – AIB base board to riser, historic damage

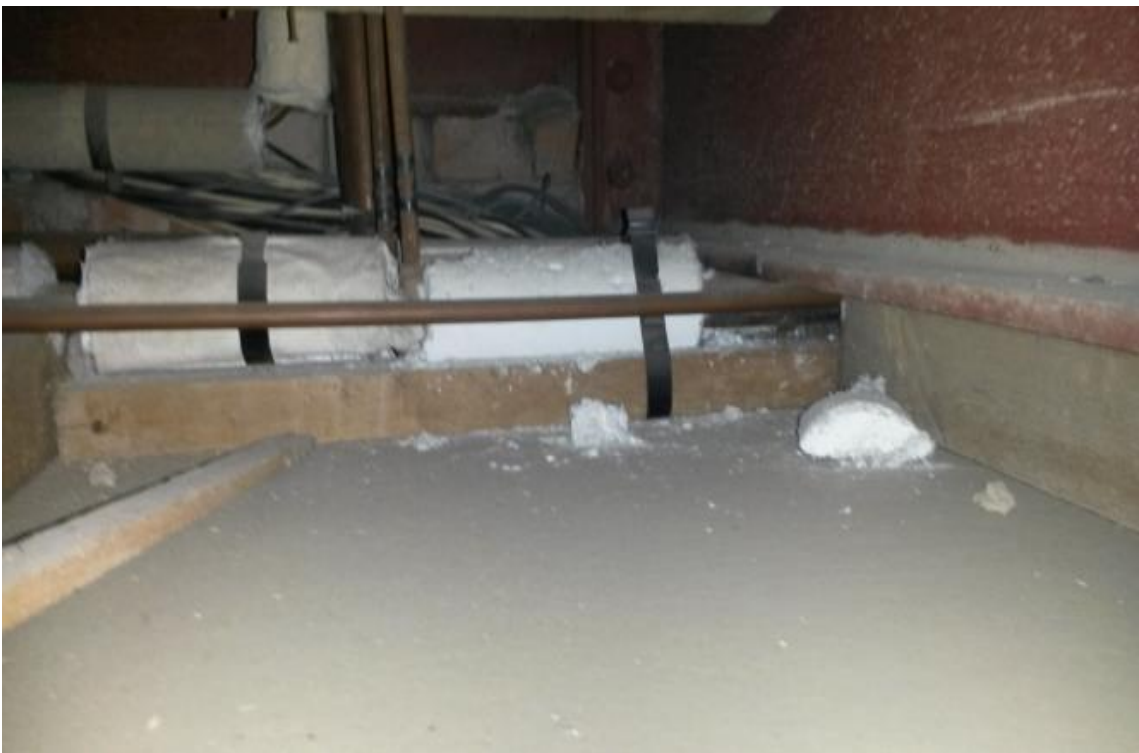
AIB debris in ceiling void of a school - insulation debris to back of non-asbestos suspended ceiling

Sometimes, asbestos debris is found in enclosed spaces – for example, the ceiling void above a false or suspended ceiling made of AIB ceiling tiles. Here the asbestos debris is likely to be a result of the original construction of the building. Poorly executed asbestos removal in the past or uncontrolled work on ACMs and a failure to clear up afterwards can also result in debris.

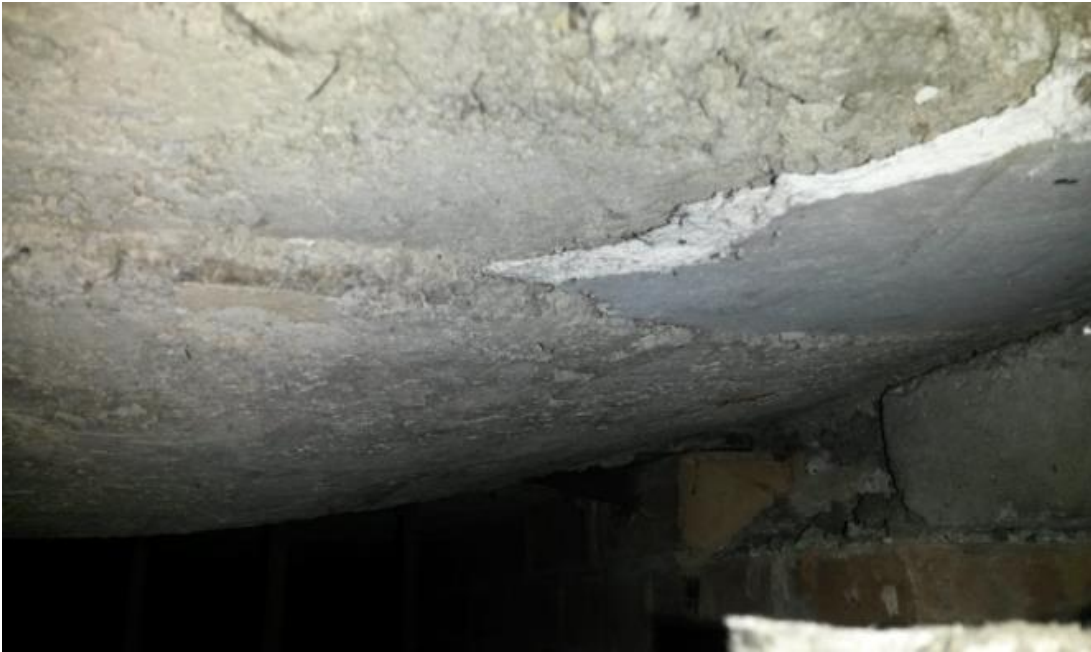
Sub floor heating ducts – insulation board shuttering around duct hatches

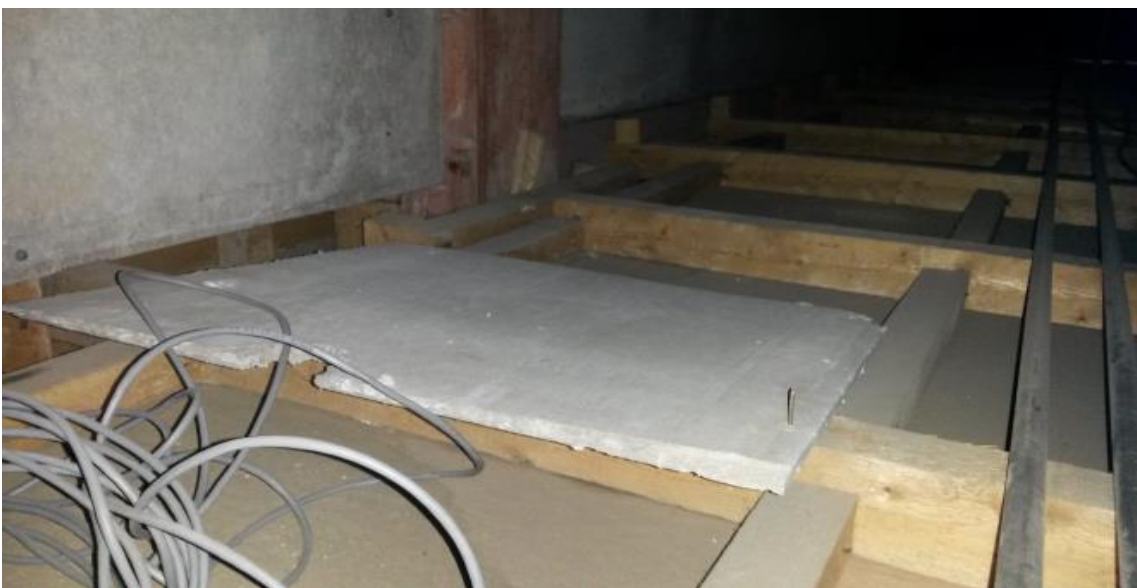
Asbestos firebreak in ceiling void of a school

Firebreaks in ceiling voids can be made of asbestos cloth; seals on boilers and pipe work can be made of asbestos ropes and yarns.

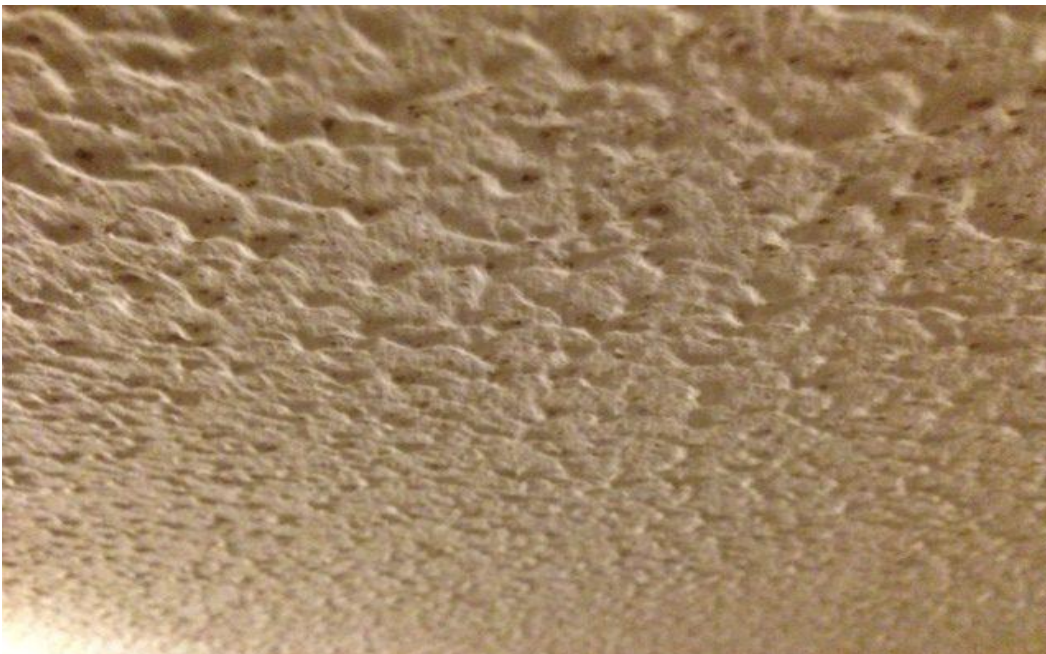
Sprayed asbestos on the ceiling of a school corridor – sprayed asbestos above suspended ceiling

Sprayed asbestos was used mainly for fire protection and insulation - applied to beams, columns, ceilings, walls and the underside of floors until spraying ceased in 1974. It has a high content of asbestos fibres.

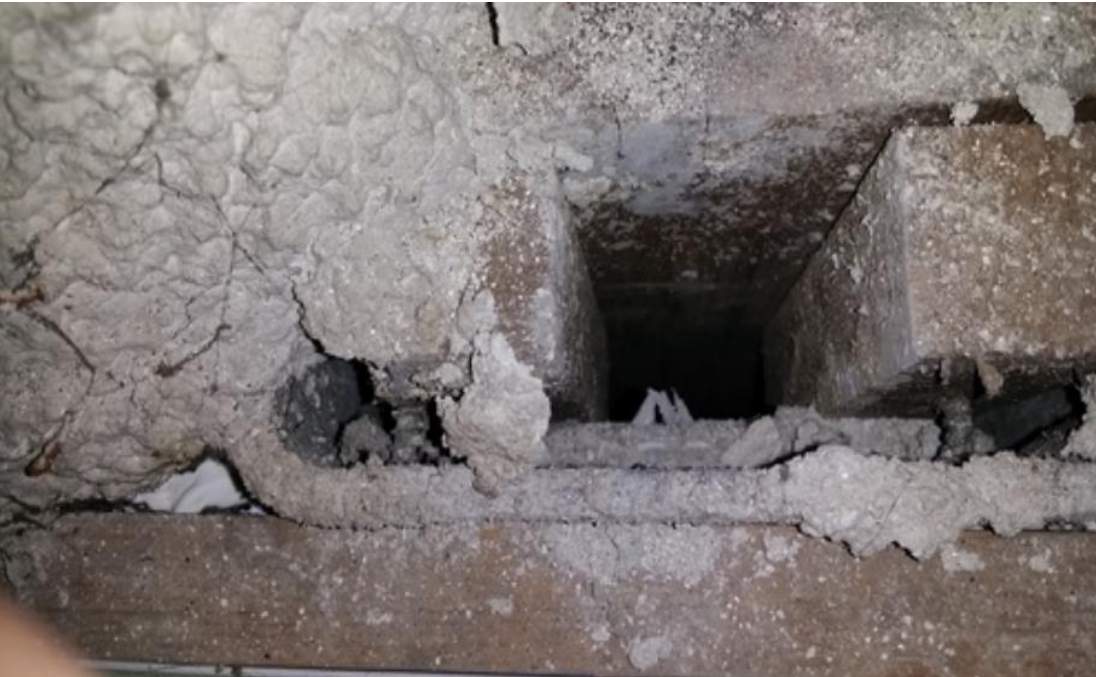
Sprayed asbestos on a column of system built school – lining behind cement wall end and column linings

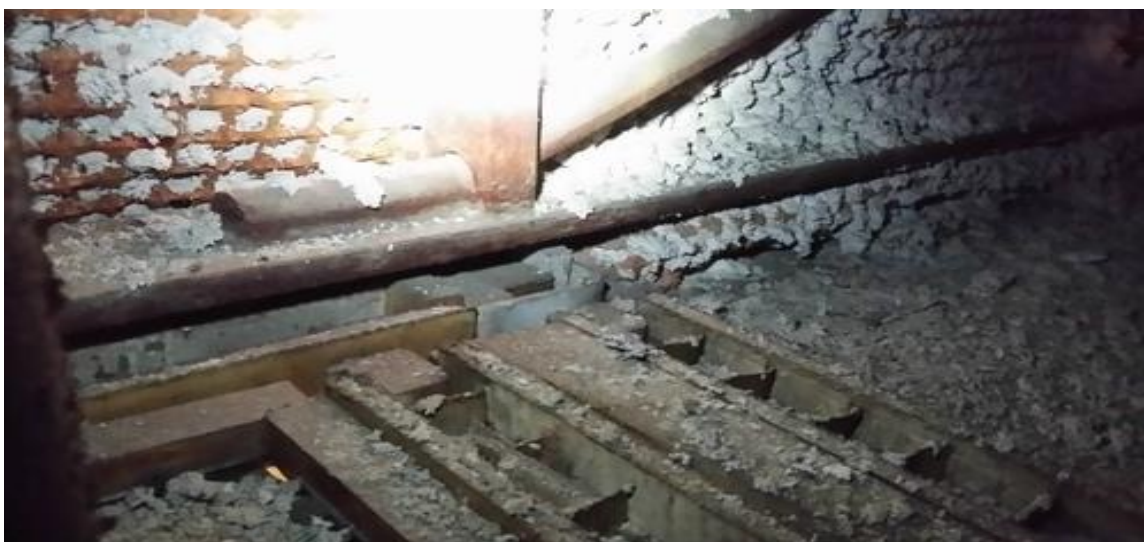
Sprayed asbestos on a column of system built school – Steel frame, wrapped in perforated steel with blown asbestos (note pattern on top left)
